MILESTONE INSPECTION - PHASE II REPORT

Seminole Square Apartment No III Association, Inc. 11620 Park Boulevard Seminole, Pinellas County, FL 33772

SOCOTEC Project Number VS233441

June 26, 2024

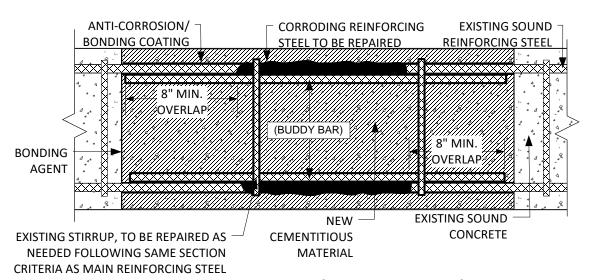
DETAILS

REINFORCING STEEL (REPRESENTATIVE) WITH SECTION LOSS OF 10% TO 25%

REINFORCING STEEL (REPRESENTATIVE) WITH SECTION LOSS GREATER THAN 25%

EPOXIED IN SPLICE APPROVED EPOXY BONDING-ANTI-CORROSION/ REINFORCING STEEL MATERIAL BONDING COATING **AGENT** 'EMBED. DEPTH (BUDDY BAR) **EXISTING STIRRUP, TO BE** 48 BAR DIA. REPAIRED AS NEEDED FOLLOWING SAME SECTION CRITERIA AS MAIN REINFORCING STEEL **EXISTING SOUND** CORRODING REINFORCING NEW CEMENTITIOUS STEEL TO BE REPLACED **REINFORCING STEEL** MATERIAL **EXISTING SOUND CONCRETE**

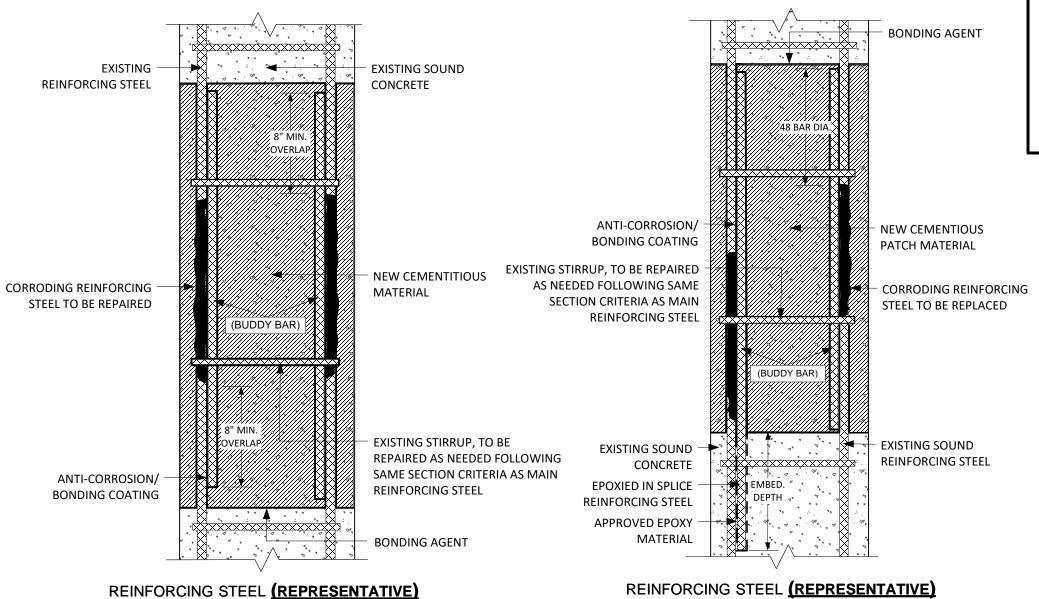
COLUMN RESTORATION DETAILS

REINFORCING STEEL (REPRESENTATIVE) WITH SECTION LOSS GREATER THAN 25% **COLUMN REPAIR**

WITH SECTION LOSS OF 10% TO 25%
