MILESTONE INSPECTION - PHASE II REPORT

Seminole Square Apartment No III Association, Inc. 11620 Park Boulevard Seminole, Pinellas County, FL 33772

SOCOTEC Project Number VS233441

June 26, 2024

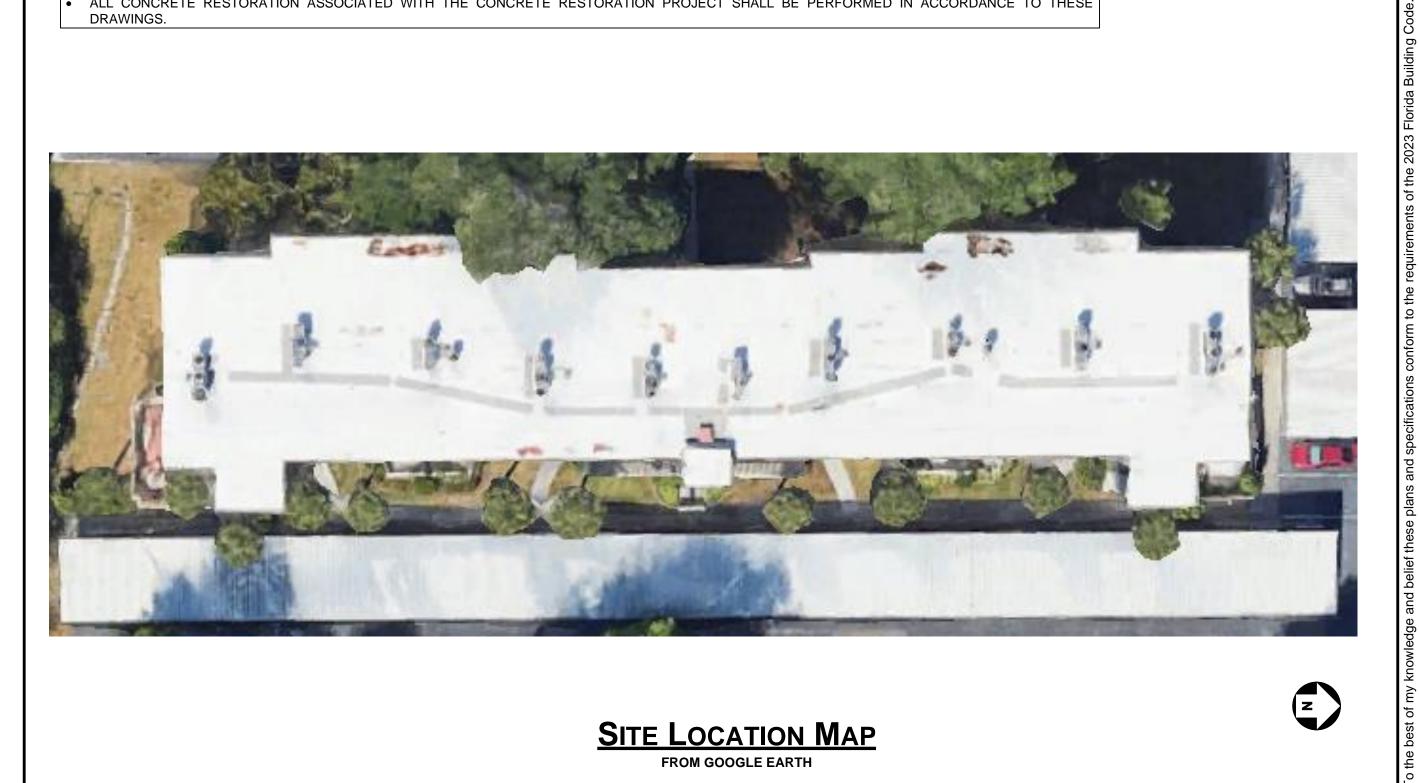
SOCOTEC & LOCATION GENERAL NOTES Sheet 1 of

- THESE PLANS SHOW THE REMEDIATION DETAILS FOR RESTORATION OF BEAMS OR ANY OTHER HORIZONTAL STRUCTURAL COMPONENT, COLUMNS OR ANY OTHER VERTICAL COMPONENT, AND DECK EDGES AT THE SUBJECT BUILDINGS. HOWEVER, THE SUBJECT DETAILS ARE ALSO APPLICABLE TO ANY STEEL REINFORCED CONCRETE THAT MAY REQUIRE RESTORATION DURING THE RESTORATION PROJECT.

- THE LOCATION OF THE REINFORCING STEEL SHOWN ON THESE PLANS IS APPROXIMATE TO INDICATE THE REINFORCING STEEL FOR REMEDIATION
- ALL CONCRETE RESTORATION ASSOCIATED WITH THE CONCRETE RESTORATION PROJECT SHALL BE PERFORMED IN ACCORDANCE TO THESE DRAWINGS.

- PRIOR TO ANY CONCRETE RESTORATION, THE METAL RAILING, SCREEN ENCLOSURE, ETC. SHALL BE REMOVED IF IT LIMITS PERFORMANCE OF THE REQUIRED RESTORATION.
- ONCE THE CONCRETE HAS BEEN EXPOSED, THE CONTRACTOR SHALL SOUND THE CONCRETE TO DETERMINE ALL AREAS OF CORRODING REINFORCING STEEL OR COMPROMISED CONCRETE.

- CONCRETE SHALL BE REMOVED FROM ALL AREAS SUSPECTED TO BE LOOSE, DELAMINATED, CRACKED, OR CONCEALING CORRODING REINFORCING STEEL
- ONCE THE CONCRETE HAS BEEN REMOVED, THE CONTRACTOR SHALL COORDINATE AN INSPECTION BY A SOCOTEC REPRESENTATIVE TO DOCUMENT THAT ALL LOOSE, DELAMINATED. CRACKED CONCRETE HAS BEEN REMOVED AND ALL ACTIVELY CORRODING REINFORCING STEEL HAS BEEN REMOVED OR CLEANED AND COATED.

- CORRODED REINFORCING STEEL SHALL BE EXPOSED BACK TO SOUND STEEL SHOWING NO EVIDENCE OF SIGNIFICANT CORROSION.
- ALL EXPOSED REINFORCING STEEL SHALL BE MECHANICALLY CLEANED DOWN TO SOUND GREY STEEL.

- ALL REINFORCING STEEL WITH A SECTION LOSS GREATER THAN 25% SHALL BE REPLACED WITH NEW REINFORCING STEEL OF EQUAL SIZE (BAR DIA.). THE BAR MUST EXTEND A MINIMUM OF 48 BAR DIAMETERS PAST BOTH ENDS OF THE AFFECTED REMOVED REINFORCING STEEL.

- COAT ALL EXPOSED REINFORCING STEEL AND COAT EDGES OF CONCRETE TO BE PATCHED WITH A SUITABLE BONDING AGENT AND REINFORCEMENT PROTECTION SUCH AS SIKA ARMATEC 110 EPOCEM. EQUIVALENT. OR BETTER IN COMPLIANCE WITH THE MANUFACTURER'S RECOMMENDATIONS.

- ONCE THE REINFORCING STEEL HAS BEEN CLEANED, REPAIRED, THE ADDITIONAL REINFORCING STEEL HAS BEEN ADDED AS REQUIRED, AND THE BONDING AGENT APPLIED, THE CONTRACTOR MUST COORDINATE A SECOND INSPECTION BY SOCOTEC PERSONNEL

- ONCE SOCOTEC HAS PERFORMED THE SECOND INSPECTION AND RELEASED THE AREA OF RESTORATION FOR CONCRETE PLACEMENT, THE AREAS OF REMOVED CONCRETE SHALL BE PATCHED WITH A POLYMER MODIFIED, HIGH STRENGTH CONCRETE MATERIAL SPECIFICALLY MANUFACTURED FOR CONCRETE RESTORATION SUCH AS SIKACRETE 211 SCC PLUS (MINIMUM COMPRESSIVE STRENGTH 6,500 PSI), EQUIVALENT, OR BETTER IN COMPLIANCE WITH THE MANUFACTURERS RECOMMENDATIONS.
